**Flood Control Project Maintenance  
Levee Inspections**

## 2013 Channel Summary Report

## Merced Streams Group

**Flood Control Project Maintenance****Unit Cover Sheet****2013 Channel Inspection Results****Merced Streams Group**

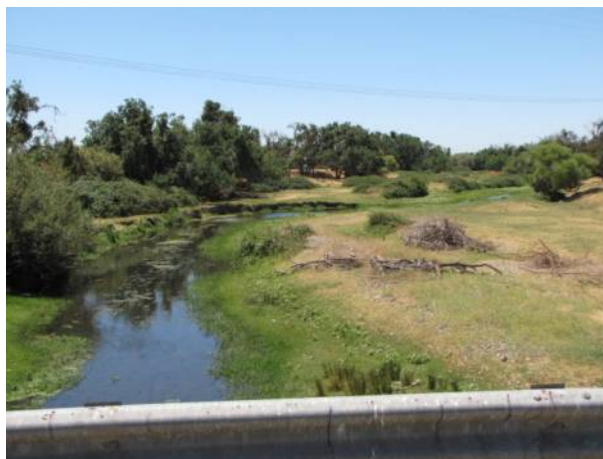
Levee Mile Report Line	6
Start Levee Mile	0.00
End Levee Mile	0.00
Location	
Category	Channels
Item	Vegetation & Obstructions
Bonner Rd. crossing the Bear Creek. Photo taken 7-18-2013.	
phillips_c_20130807_105.JPG

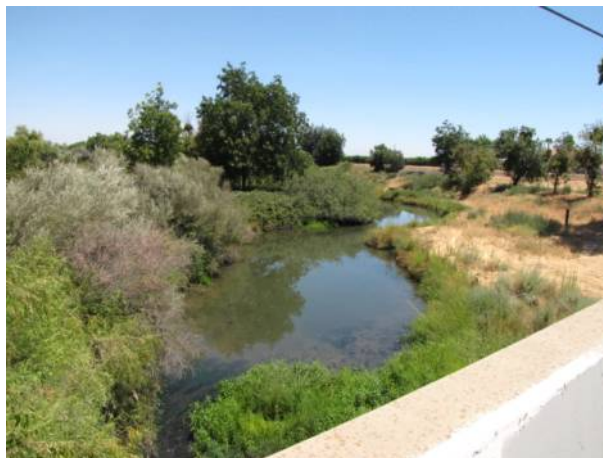
Levee Mile Report Line	11
Start Levee Mile	0.00
End Levee Mile	0.00
Location	
Category	Channels
Item	Vegetation & Obstructions
Arboleda Dr. looking upstream of Bear Creek. Photo taken 7-18-2013.	
phillips_c_20130807_106.JPG

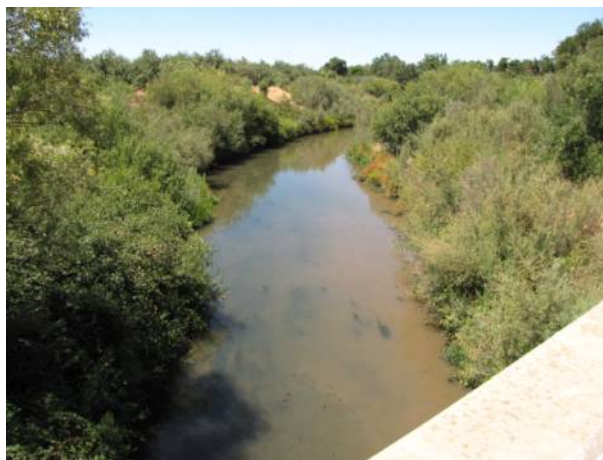
Arboleda Dr. crossing the Bear Creek. Photo taken 7-18-2013.

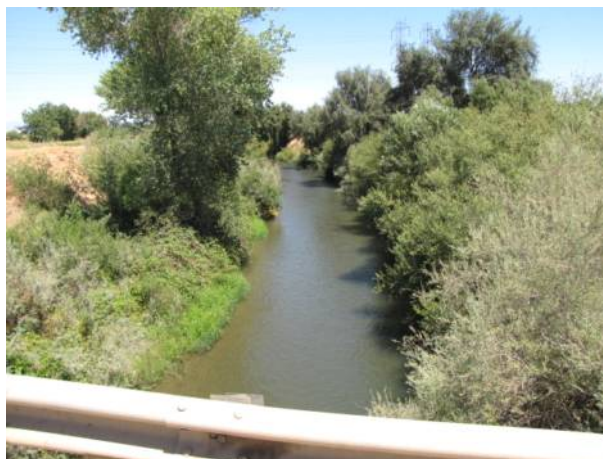
Levee Mile Report Line	21
Start Levee Mile	0.00
End Levee Mile	0.00
Location	
Category	Channels
Item	Vegetation & Obstructions

Kibby Rd bridge crossing Bear Creek looking upstream. Photo taken 7-18-2013.

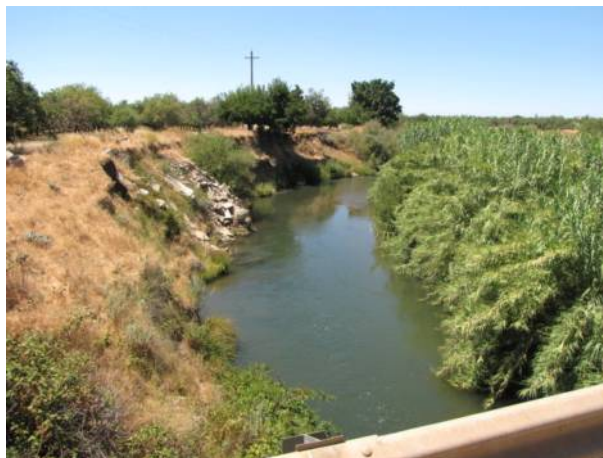
Levee Mile Report Line	26
Start Levee Mile	0.00
End Levee Mile	0.00
Location	
Category	Channels
Item	Vegetation & Obstructions

Kibby Rd crossing the Bear Creek looking downstream. Photo taken 7-18-2013.

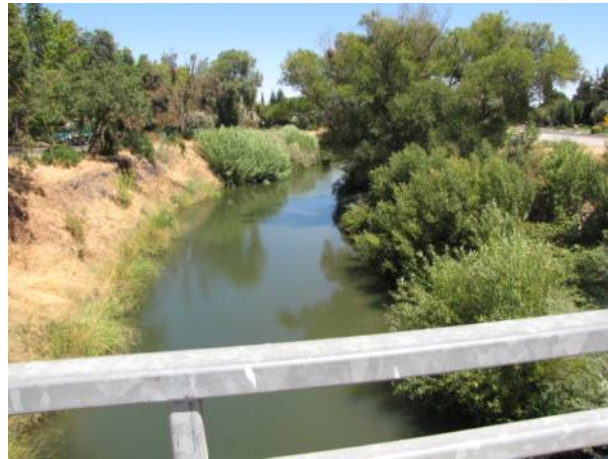
McKee Rd crossing the Bear Creek. Photo taken 7-18-2013.

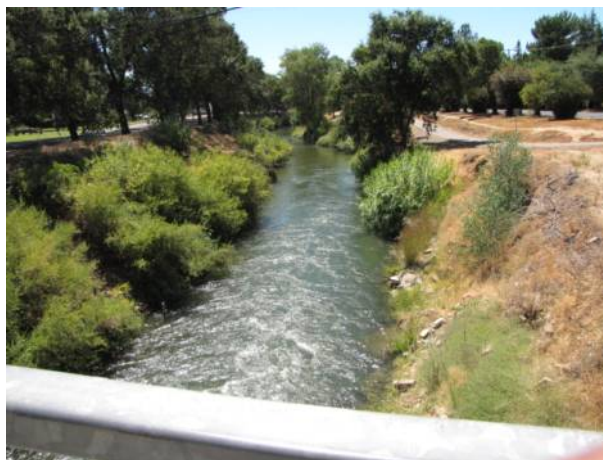
Mckee Rd. Crossing the Bear Creek looking downstream. Photo taken 7-18-2013.

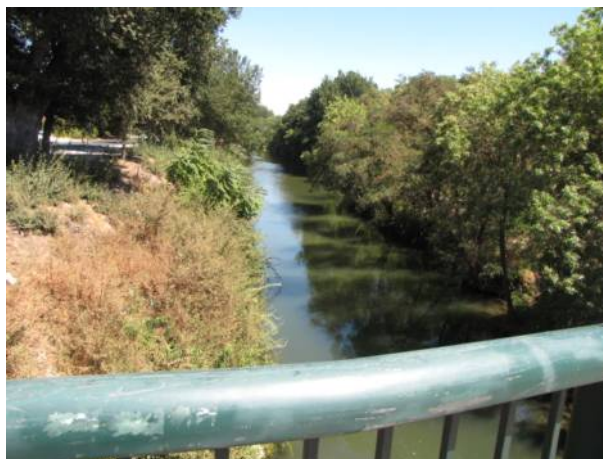
Levee Mile Report Line	41
Start Levee Mile	0.00
End Levee Mile	0.00
Location	
Category	Channels
Item	Vegetation & Obstructions

Bear Creek looking upstream from R street bridge crossing. Photo taken 7-18-2013.

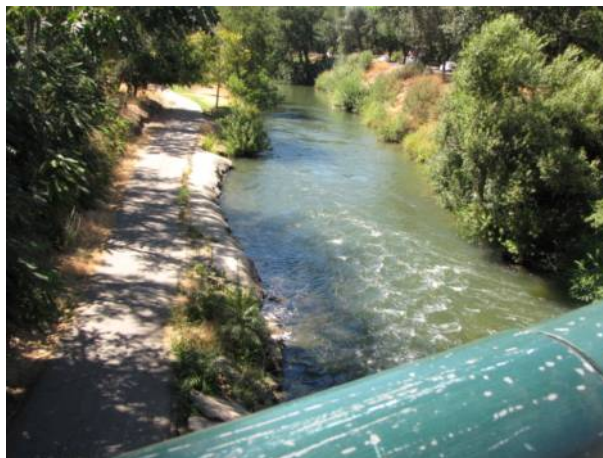
Levee Mile Report Line	46
Start Levee Mile	0.00
End Levee Mile	0.00
Location	
Category	Channels
Item	Vegetation & Obstructions

Looking downstream from R street bridge the Bear Creek. Photo taken 7-18-2013.

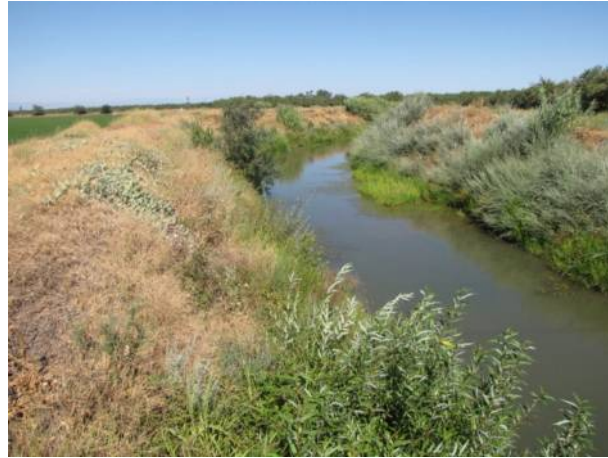
Bear Creek looking upstream from Franklin Road crossing. Photo taken 7-18-2013.

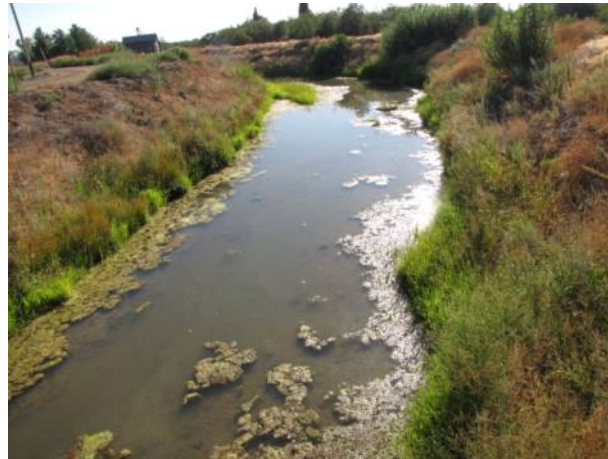
Levee Mile Report Line	56
Start Levee Mile	0.00
End Levee Mile	0.00
Location	
Category	Channels
Item	Vegetation & Obstructions

Bear Creek looking downstream from Franklin Rd crossing. Photo taken 7-30-2012.

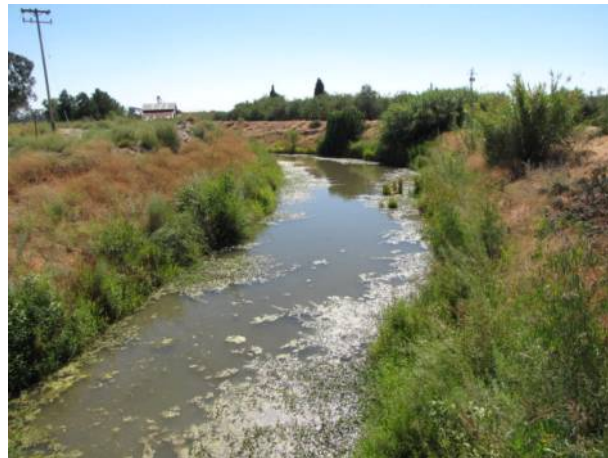
Levee Mile Report Line	56
Start Levee Mile	0.00
End Levee Mile	0.00
Location	
Category	Channels
Item	Vegetation & Obstructions

Looking downstream from the Franklin Road crossing Bear Creek. Photo taken 7-18-2013.

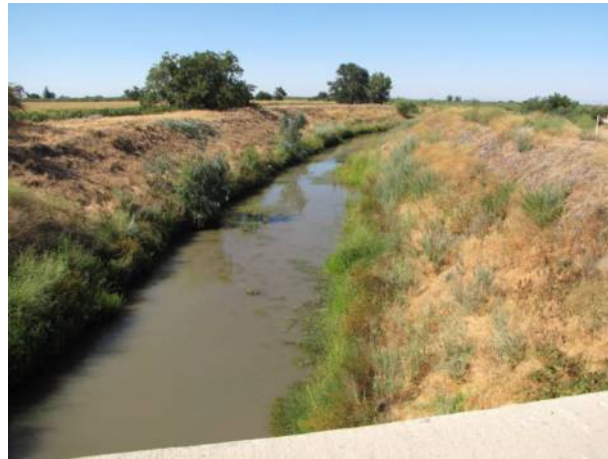
Levee Mile Report Line	61
Start Levee Mile	0.00
End Levee Mile	0.00
Location	
Category	Channels
Item	Vegetation & Obstructions
Bear Creek looking upstream from Hwy 140 bridge crossing. Photo taken 7-18-2013.	
phillips_c_20130819_119.JPG

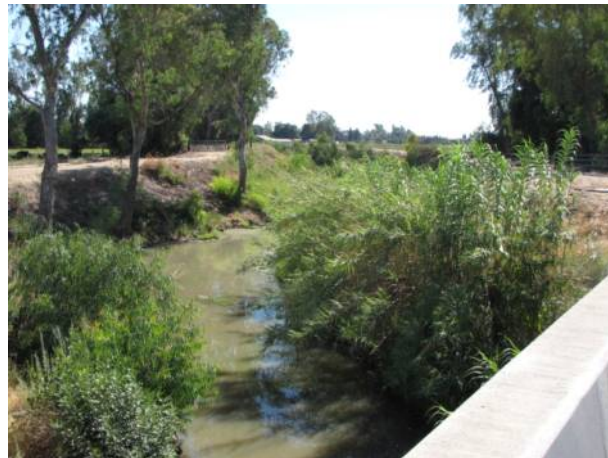
Levee Mile Report Line	66
Start Levee Mile	0.00
End Levee Mile	0.00
Location	
Category	Channels
Item	Vegetation & Obstructions
Bear Creek looking downstream from Hwy 140 bridge crossing, young willows and bambo present on both banks. Photo taken 7-18-2013.	
phillips_c_20130819_121.JPG

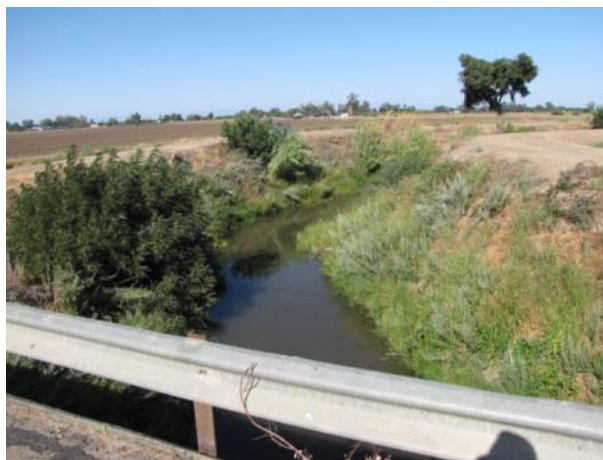
Bear Creek looking upstream from Buhach Rd crossing. Photo taken 7-18-2013.

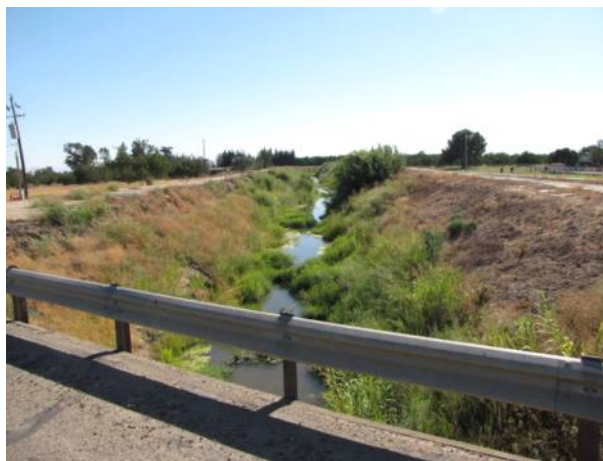
Levee Mile Report Line	75
Start Levee Mile	0.00
End Levee Mile	0.00
Location	
Category	Channels
Item	Vegetation & Obstructions

Bear Creek looking downstream from Buhach Rd. Photo taken 7-18-2013.

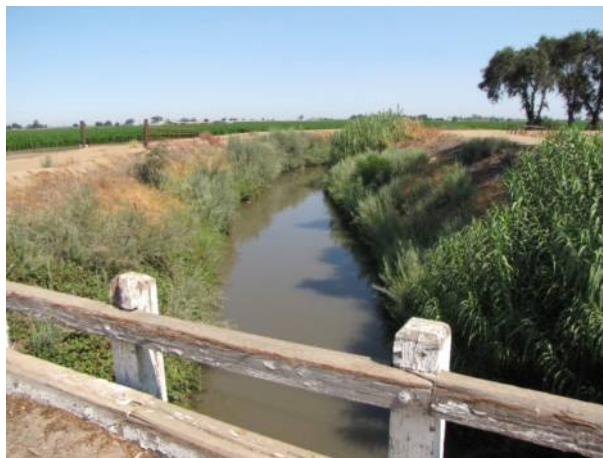
Levee Mile Report Line	80
Start Levee Mile	0.00
End Levee Mile	0.00
Location	
Category	Channels
Item	Vegetation & Obstructions

Bear Creek looking upstream from Dickerson Ferry Rd bridge crossing. Photo taken 7-18-2013.

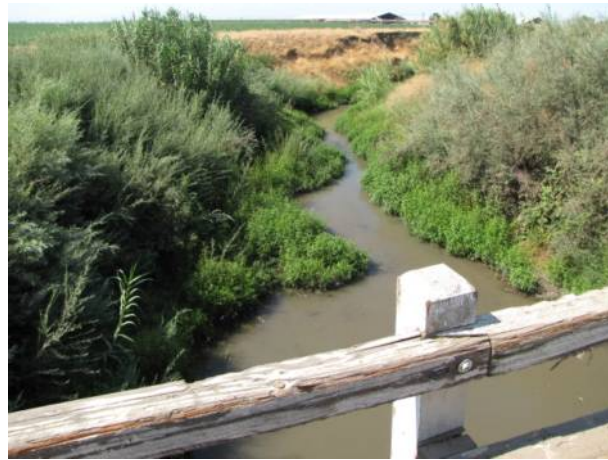
Bear Creek looking downstream from Dickerson Ferry Rd. bridge crossing. Photo taken 7-18-2013.

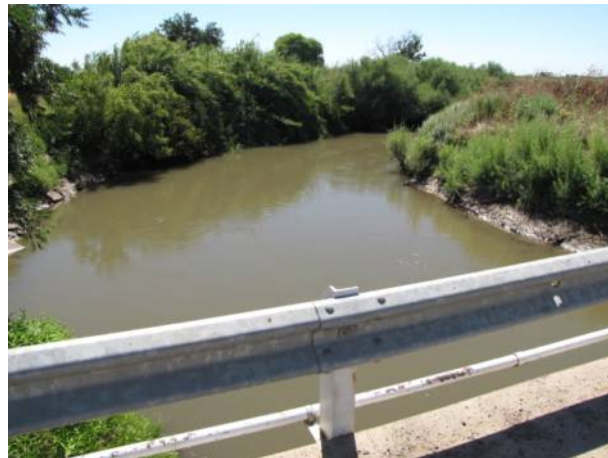
Bert Crane Rd. crossing the Bear Creek looking upstream at channel. Photo taken 7-30-2012. No new photo was taken 7-18-2013.

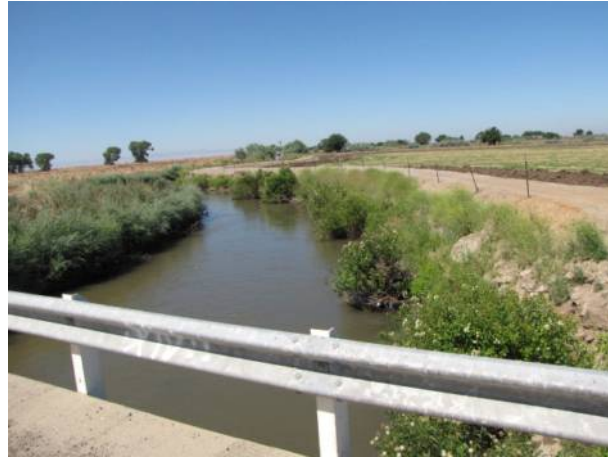
Bert Crane Rd. Crossing the Bear Creek looking downstream. Photo taken 7-30-2012. No new photo taken at this location, 7-18-2013.

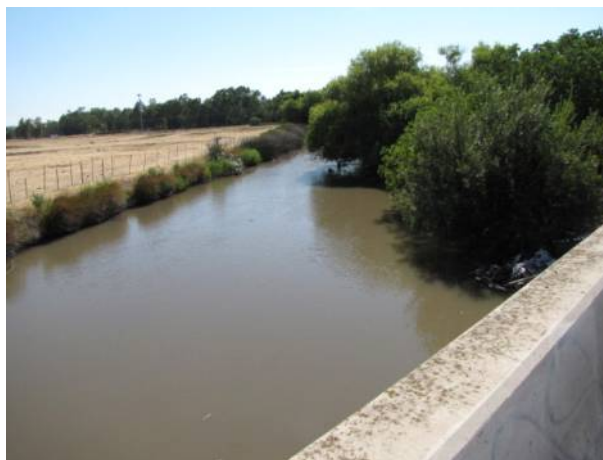
Santa Fe Drive crossing the Black Rascal Creek looking upstream. Photo taken 7-24-2013.

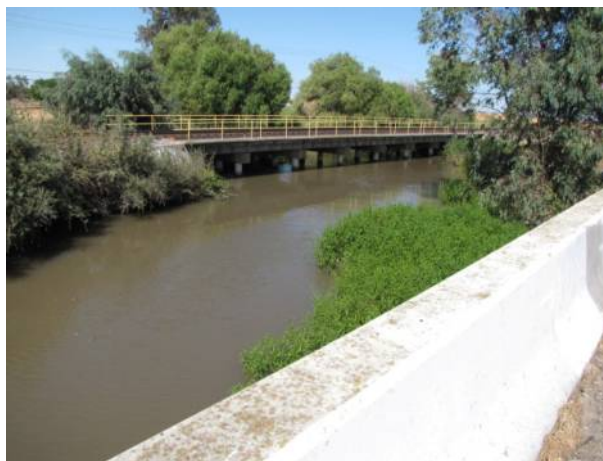
Levee Mile Report Line	6
Start Levee Mile	0.00
End Levee Mile	0.00
Location	
Category	Channels
Item	Vegetation & Obstructions

Santa Fe Drive crossing Black Rascal Creek looking downstream from bridge. Photo taken 7-24-2013.

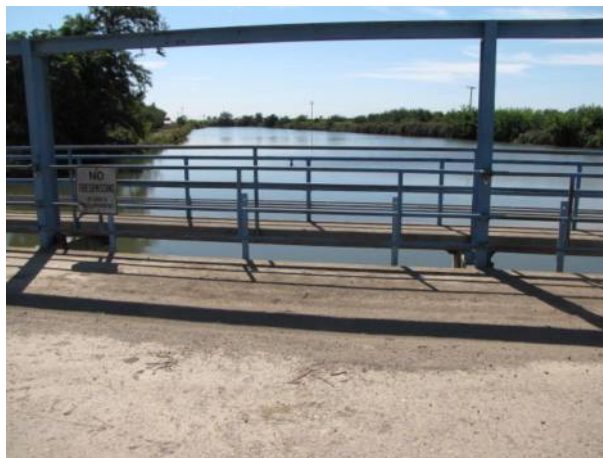
Levee Mile Report Line	11
Start Levee Mile	0.00
End Levee Mile	0.00
Location	
Category	Channels
Item	Vegetation & Obstructions

Looking upstream from Crocker Dam crossing the Black Rascal Creek. Photo taken 7-24-2013.

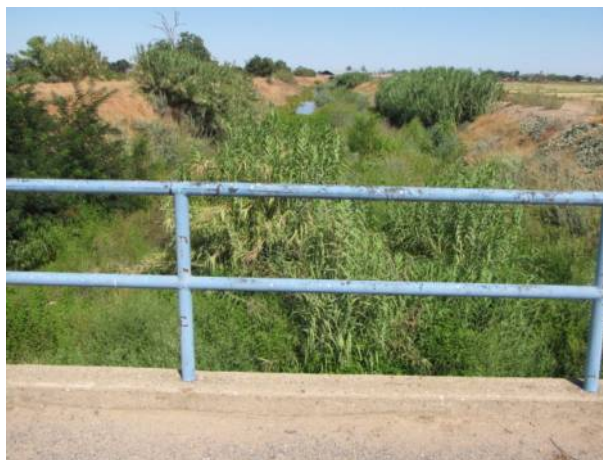
Looking downstream from the Crocker Dam. Vegetation in channel and both banks downstream. Photo taken 7-24-2013.

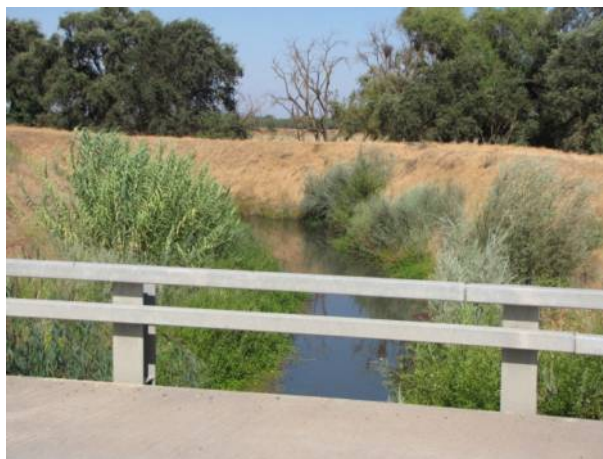
Levee Mile Report Line	21
Start Levee Mile	0.00
End Levee Mile	0.00
Location	
Category	Channels
Item	Vegetation & Obstructions

Looking upstream from the Franklin Rd. crossing at Black Rascal Creek. Photo taken 7-30-2013.

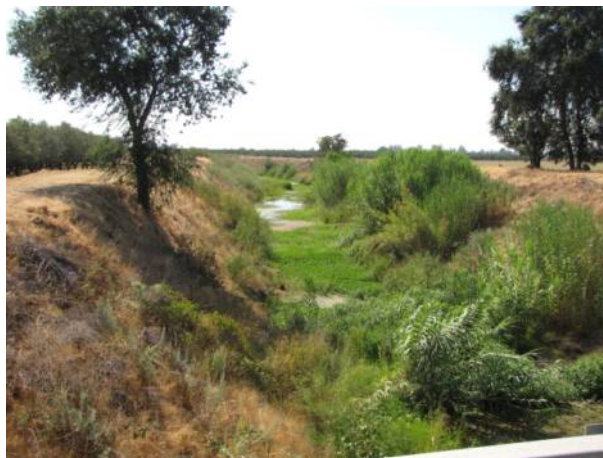
Levee Mile Report Line	26
Start Levee Mile	0.00
End Levee Mile	0.00
Location	
Category	Channels
Item	Vegetation & Obstructions

Looking downstream from the Franklin Rd. crossing at Black Rascal Creek; right banks covered with wild growth. Photo taken 7-30-2013.

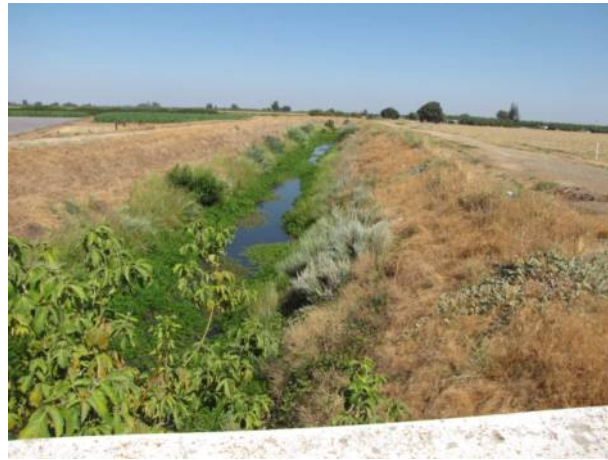
Black Rascal Creek from Gurr Road crossing.  
Photo taken 7-30-2013.

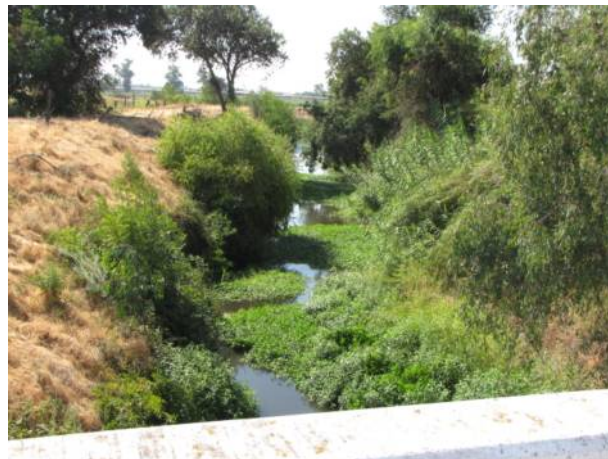
Levee Mile Report Line	36
Start Levee Mile	0.00
End Levee Mile	0.00
Location	
Category	Channels
Item	Vegetation & Obstructions

Black Rascal Creek looking downstream from the  
road crossing. Photo taken 7-30-2013.

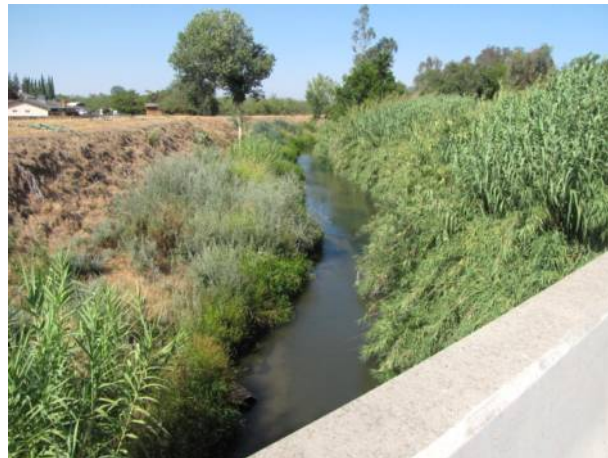
Levee Mile Report Line	41
Start Levee Mile	0.00
End Levee Mile	0.00
Location	
Category	Channels
Item	Vegetation & Obstructions

Black Rascal Creek from the Hwy 140 crossing  
the channel. Wild growth of bambo covering left  
bank, other wild growth present in channel right  
bank. Photo taken 7-30-2013.

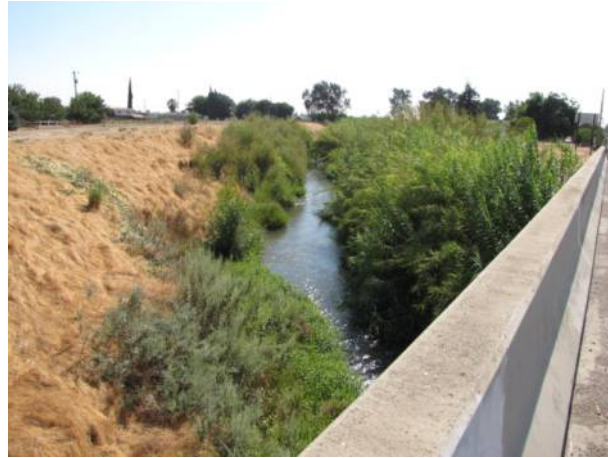
Black Rascal Creek looking downstream from Hwy 140 crossing. Right bank covered with bambo and young willow trees covering the left bank toe. Photo taken 7-30-2013.

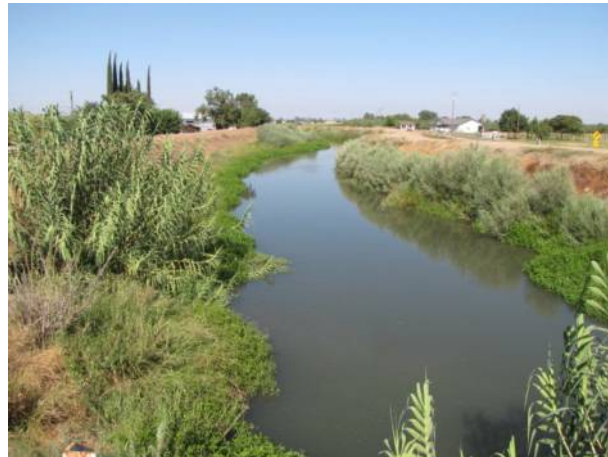
Levee Mile Report Line	51
Start Levee Mile	0.00
End Levee Mile	0.00
Location	
Category	Channels
Item	Vegetation & Obstructions

Black Rascal Creek from Quinley Rd crossing. Photo taken 7-30-2013.

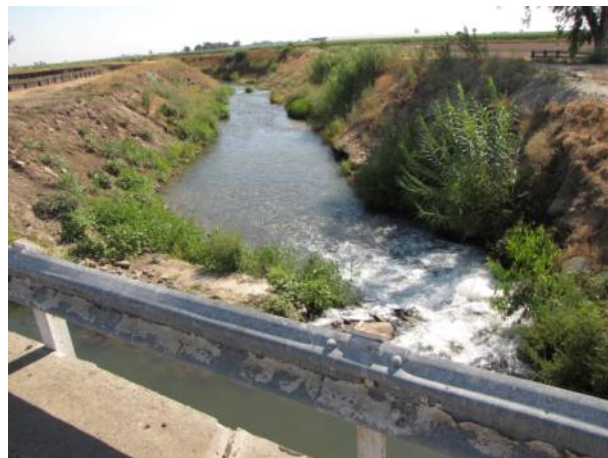
Levee Mile Report Line	56
Start Levee Mile	0.00
End Levee Mile	0.00
Location	
Category	Channels
Item	Vegetation & Obstructions

Black Rascal Creek looking downstream from bridge crossing. Photo taken 7-30-2013.

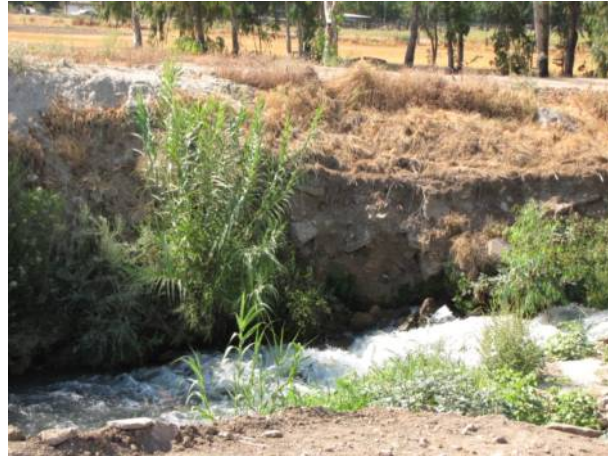
Right bank erosion vertical cut along bank. Photo taken 7-30-2013.

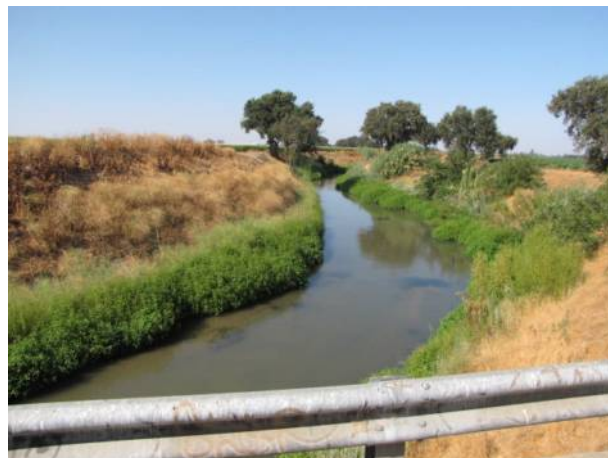
Black Rascal Creek from Oak Avenue crossing the channel. Photo taken 7-30-2013.

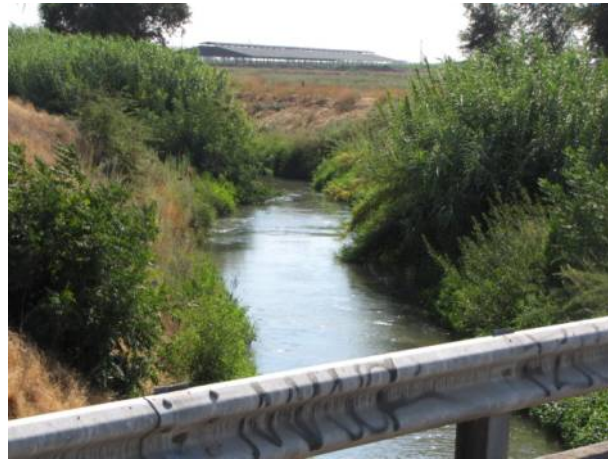
Black Rascal looking downstream from the Oak Avenue crossing. Vegetation present on both banks. Photo taken 7-30-2013.

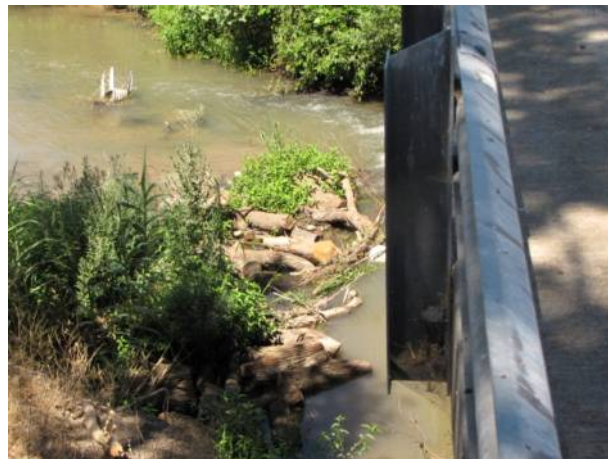
Levee Mile Report Line	70
Start Levee Mile	0.00
End Levee Mile	0.00
Location	
Category	Channels
Item	Encroachments

Black Rascal Creek looking downstream from Oak Ave. bridge crossing. Firewood dumped in channel and other material are causing the channel to divert. No new picture taken this inspection.

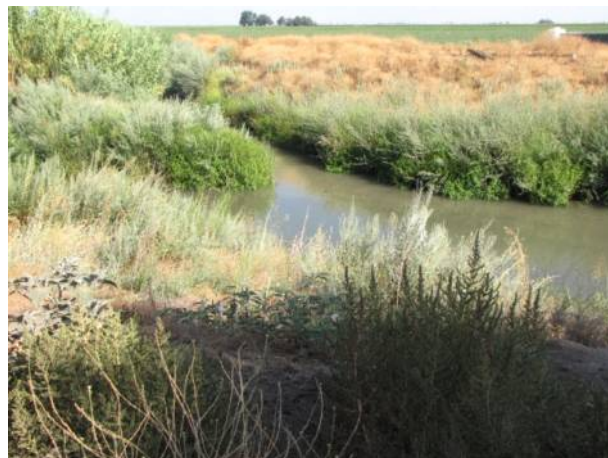
Levee Mile Report Line	71
Start Levee Mile	0.00
End Levee Mile	0.00
Location	
Category	Channels
Item	Vegetation & Obstructions

Looking upstream at the confluence of Black Rascal and the Bear creek. Photo taken 7-30-2013.

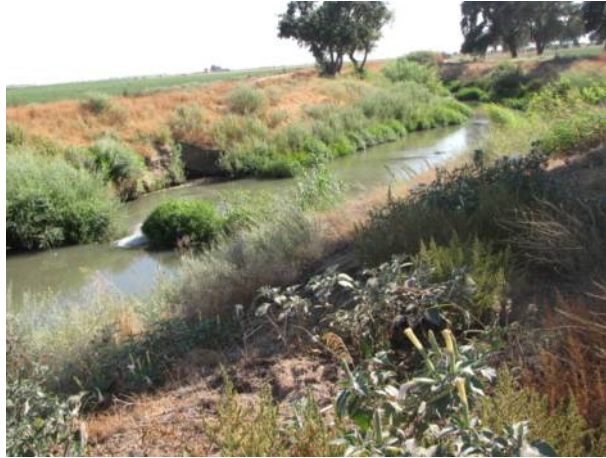
Looking downstream from the confluence at wild weed growth on both banks. Photo taken 7-30-2013.

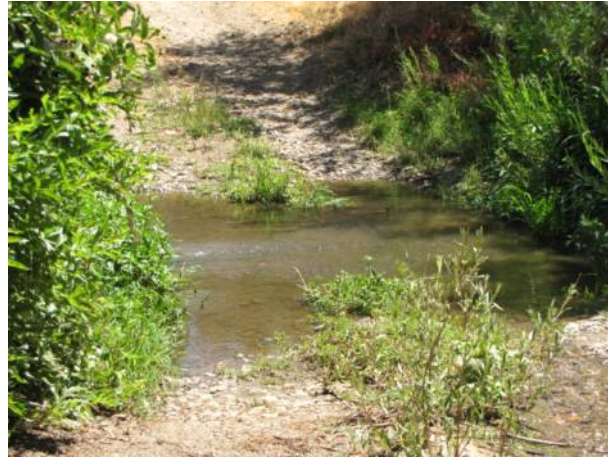
Burns Creek Low Water Crossing. Photo taken 7-18-2013.

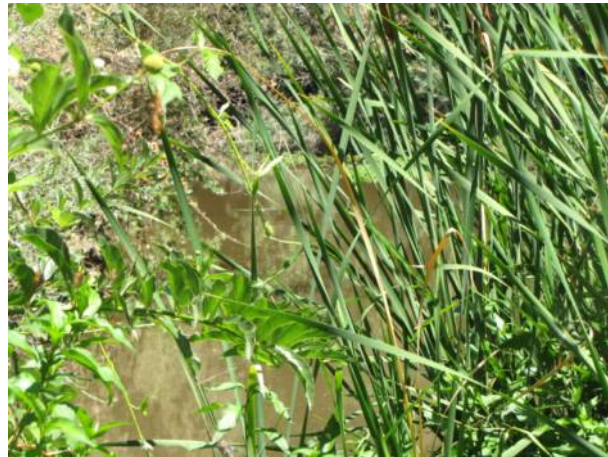
Levee Mile Report Line	6
Start Levee Mile	
End Levee Mile	
Location	
Category	Channels
Item	Vegetation & Obstructions

Low Water Crossing looking downstream minimal brush in channel.

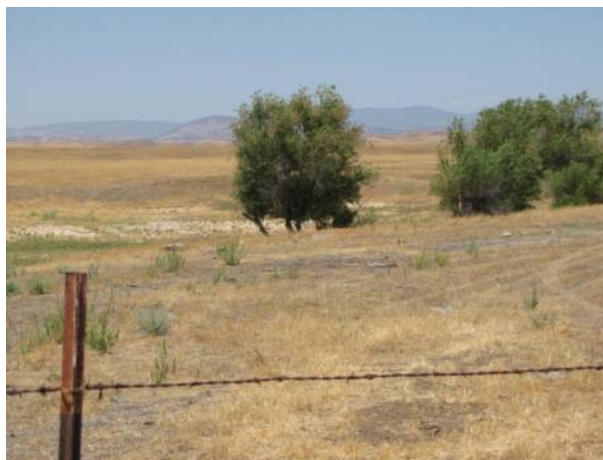
phillips\_c\_20130903\_187.JPG

Mariposa Creek looking upstream from White Rock Road. Photo taken 7-19-2013.

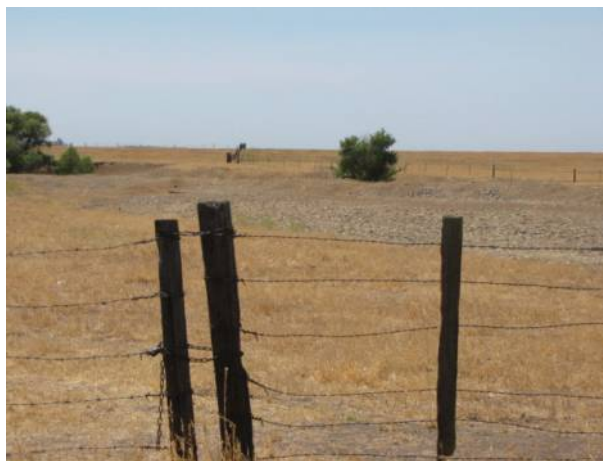
phillips\_c\_20130903\_188.JPG

Mariposa Creek looking downstream from White Rock Road. Photo taken 7-19-2013.

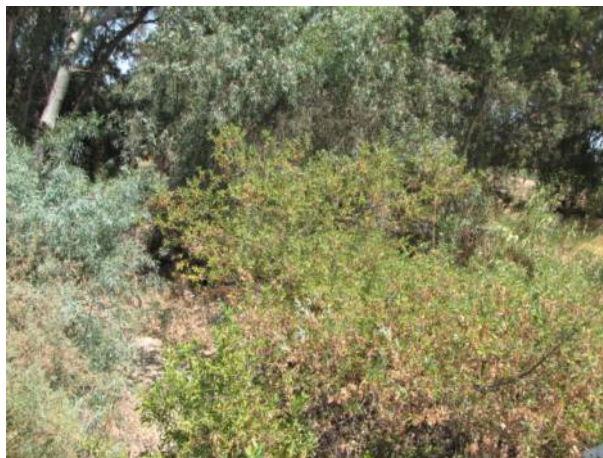
phillips\_c\_20130903\_189.JPG

Mariposa Creek looking upstream from Fresno Rd. Channel overgrown. Photo taken 7-19-2013.

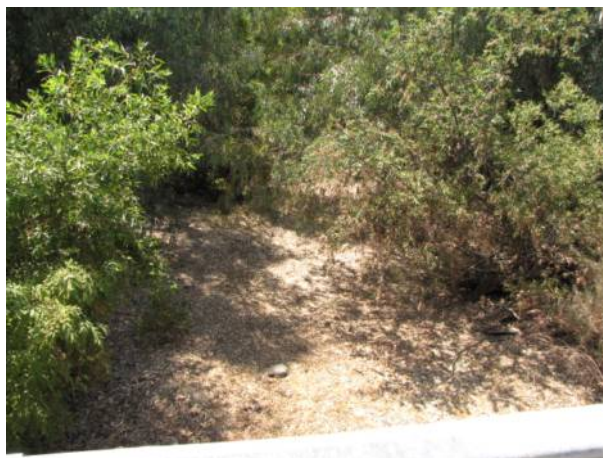
phillips\_c\_20130904\_190.JPG

Mariposa Creek looking downstream from Fresno bridge crossing. Photo taken 7-19-2013.

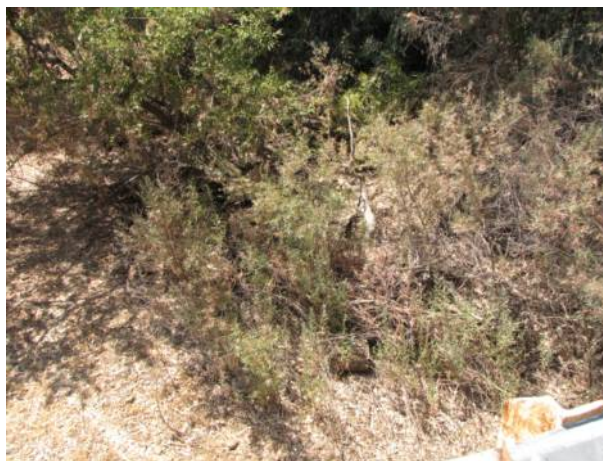
phillips\_c\_20130904\_192.JPG

Wild growth in channel along with firewood piled up in channel downstream from bridge crossing.

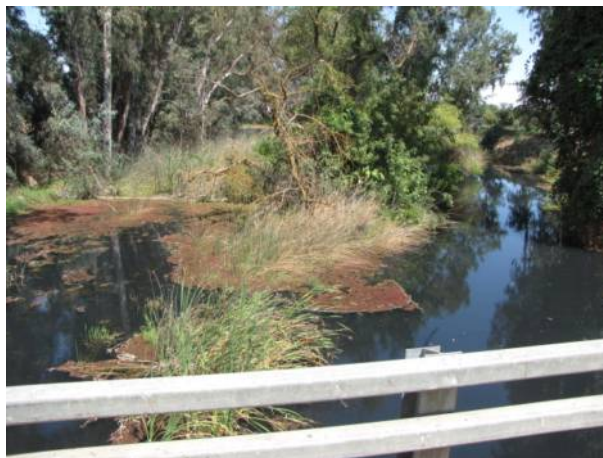
phillips\_c\_20130904\_193.JPG

Mariposa Creek looking upstream from Cunningham Rd. Photo taken 7-23-2013.

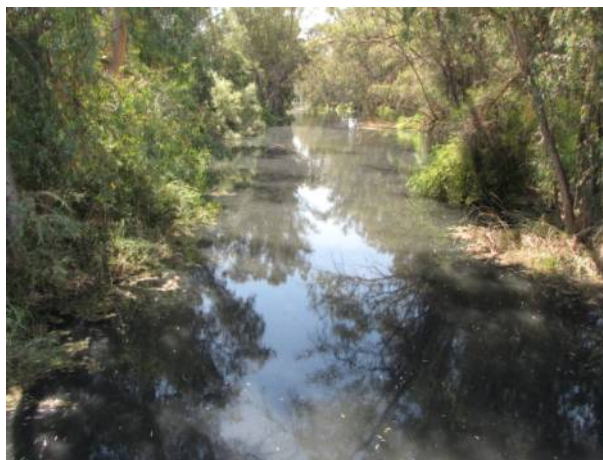
phillips\_c\_20130904\_194.JPG

Mariposa Creek looking downstream from Cunningham bridge crossing. Photo taken 7-23-2013.

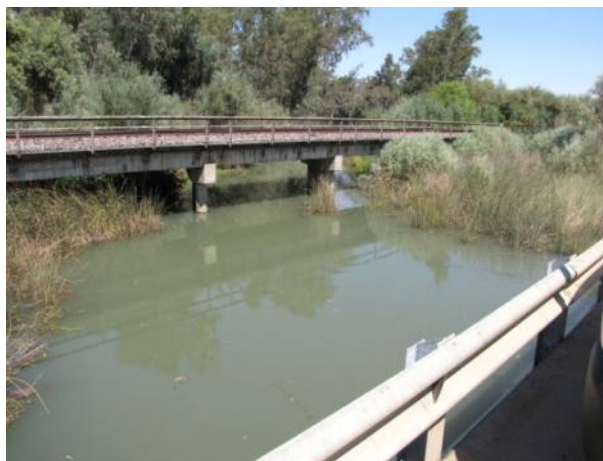
phillips\_c\_20130904\_195.JPG

Mariposa Creek looking upstream from Santa Fe Drive crossing. Photo taken 7-23-2013.

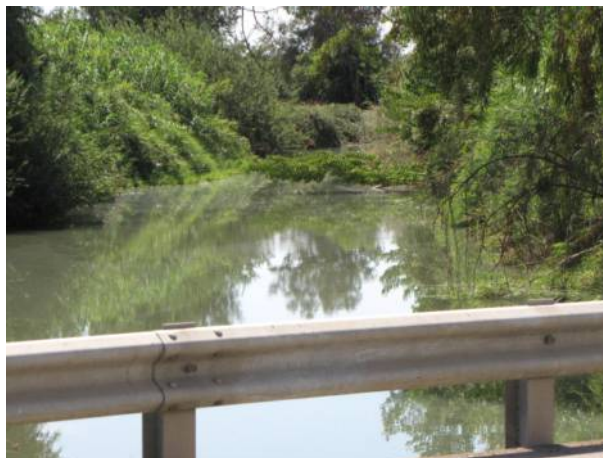
phillips\_c\_20130904\_196.JPG

Mariposa Creek looking downstream from Santa Fe bridge crossing. Photo taken 7-23-2013.

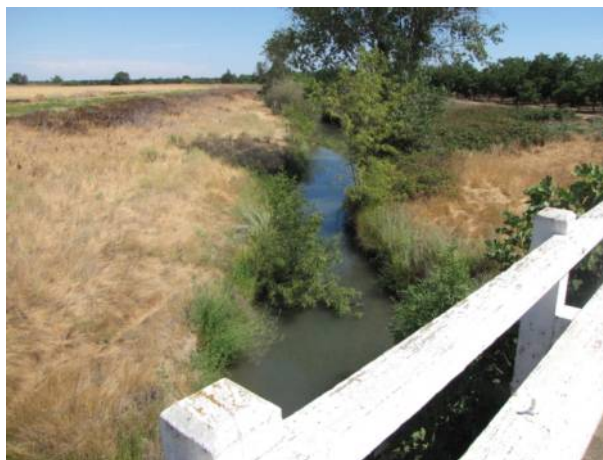
phillips\_c\_20130904\_197.JPG

Mariposa Creek looking upstream from the Burchell Rd crossing. Photo taken 7-23-2013.

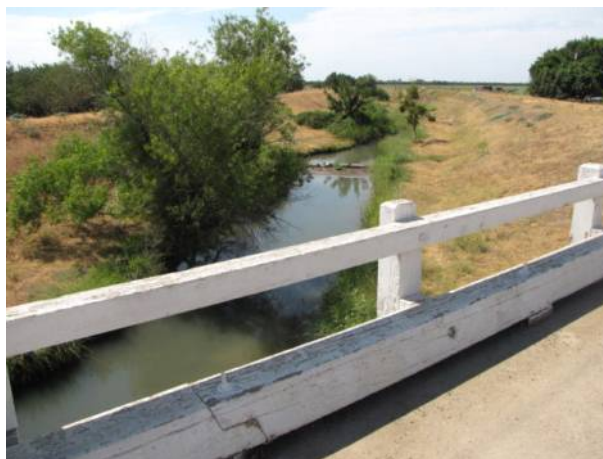
phillips\_c\_20130904\_198.JPG

Mariposa Creek looking downstream from Burchell Rd. Photo taken 7-23-2013.

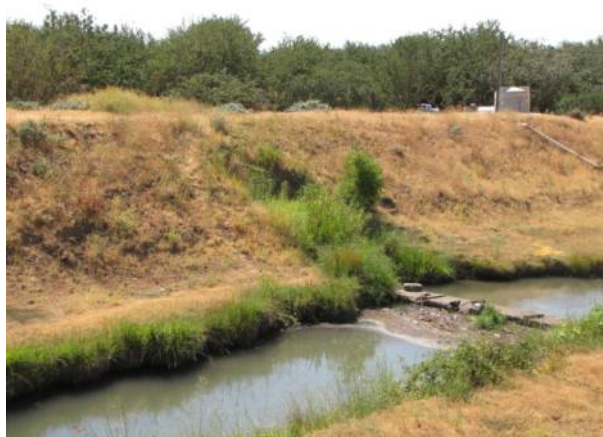
phillips\_c\_20130904\_199.JPG

Mariposa Creek left bank erosion. Photo taken 7-23-2013.

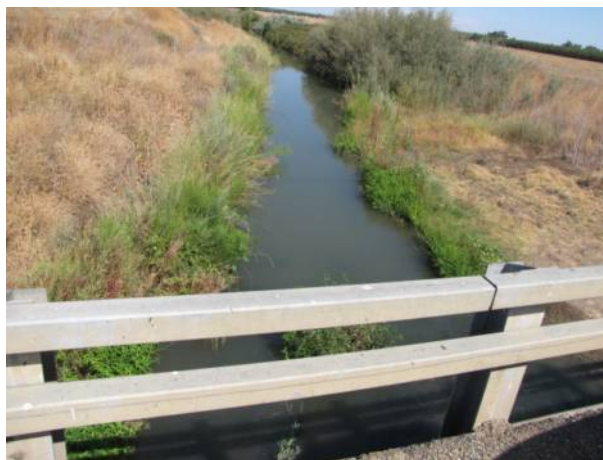
phillips\_c\_20130905\_200.JPG

Mariposa Creek looking upstream from Plainsburg Rd. crossing. Photo taken 7-23-2013.

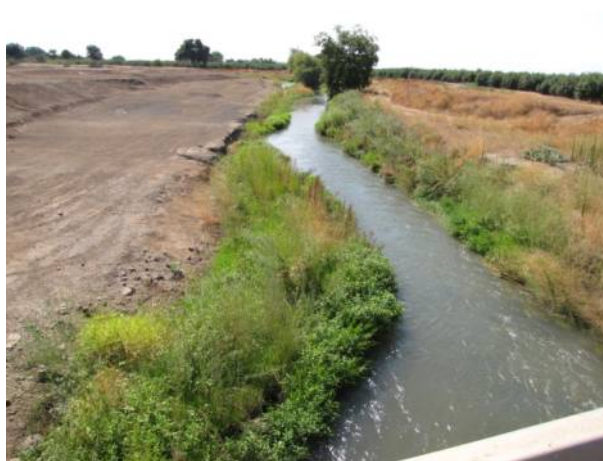
phillips\_c\_20130905\_201.JPG

Mariposa Creek looking downstream from Plainsburg Rd. crossing. Photo taken 7-23-2013.

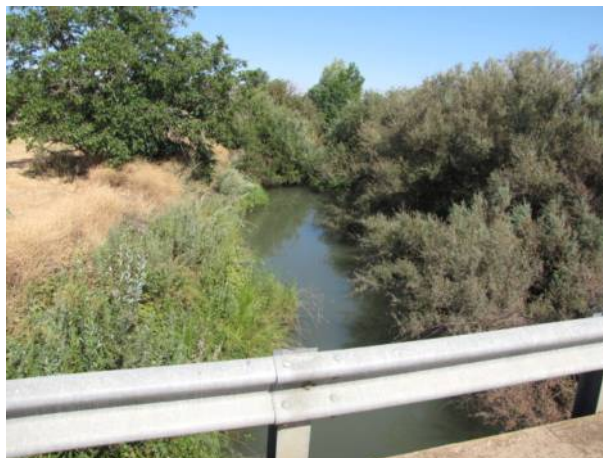
phillips\_c\_20130905\_202.JPG

Mariposa Creek looking upstream from Whealan Rd. crossing. Photo taken 7-23-2013.

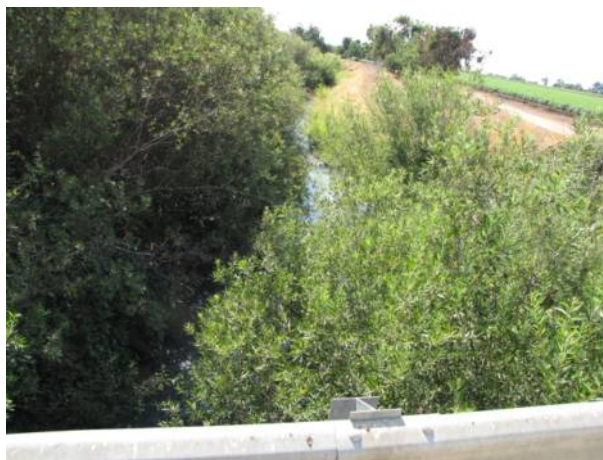
phillips\_c\_20130905\_203.JPG

Mariposa Creek looking downstream from Whealan Rd. crossing. Photo taken 7-23-2013.

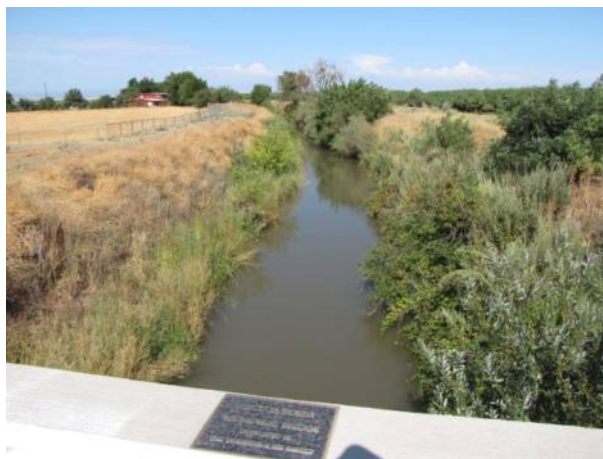
phillips\_c\_20130905\_204.JPG

Mariposa Creek looking upstream from Arboleda Rd. crossing. Photo taken 7-23-2013.

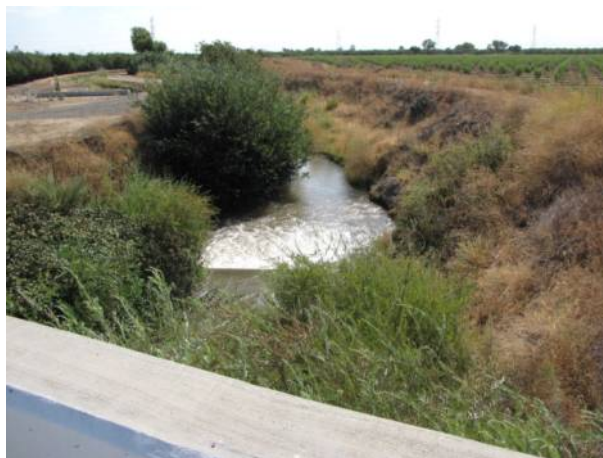
phillips\_c\_20130905\_205.JPG

Mariposa Creek looking downstream from Arboleda Rd. crossing. Photo taken 7-23-2013.

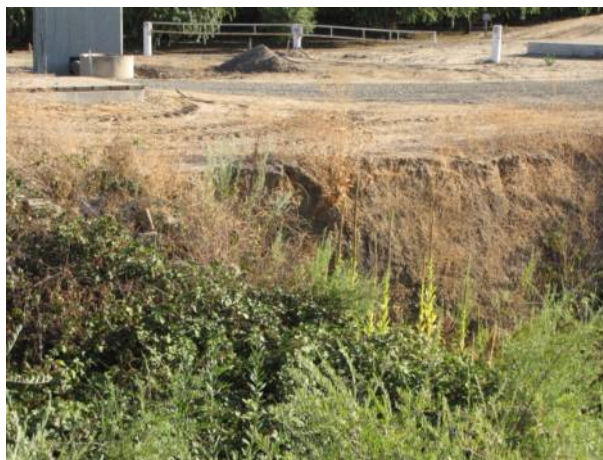
phillips\_c\_20130618\_099.jpg

Mariposa Creek erosion on the left bank. This erosion was noted on previous channel inspections. This photo was taken 7-26-2012. No updated picture taken 7-23-2013.

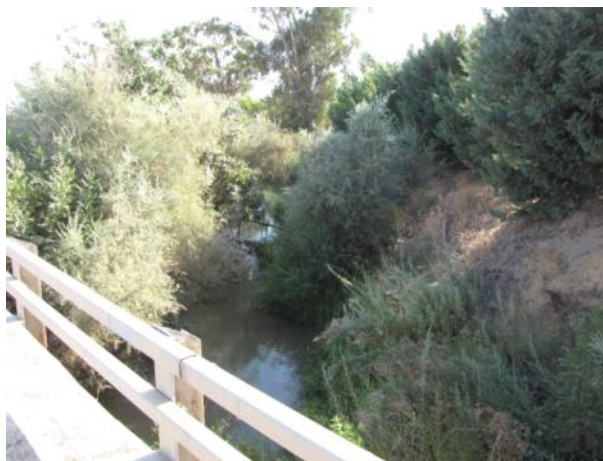
phillips\_c\_20130905\_206.JPG

Mariposa Creek looking upstream from Healy Rd. crossing. Photo taken 7-23-2013.

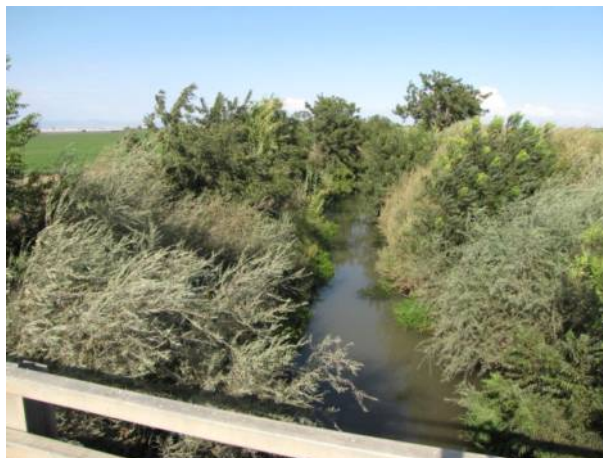
phillips\_c\_20130905\_207.JPG

Mariposa Creek looking downstream from Healy Rd. crossing. Photo taken 7-23-2013.

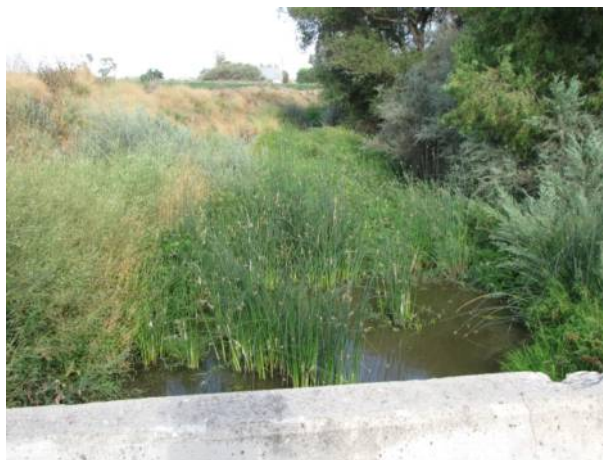
phillips\_c\_20130905\_208.JPG

Mariposa Creek looking upstream from Hwy 59.  
Photo taken 7-23-2013.

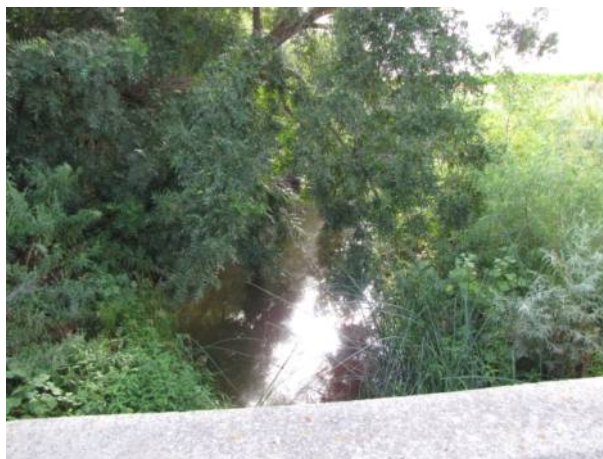
phillips\_c\_20130905\_209.JPG

Mariposa Creek looking downstream from Hwy 59. Photo taken 7-23-2013.

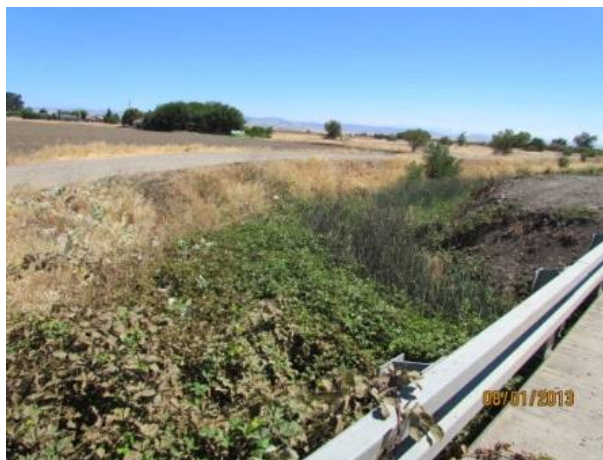
Levee Mile Report Line	1
Start Levee Mile	0.00
End Levee Mile	0.00
Location	
Category	Channels
Item	Vegetation & Obstructions
Upstream view from Childs Ave. crossing.	
mkhashch_c_20130805_053.JPG

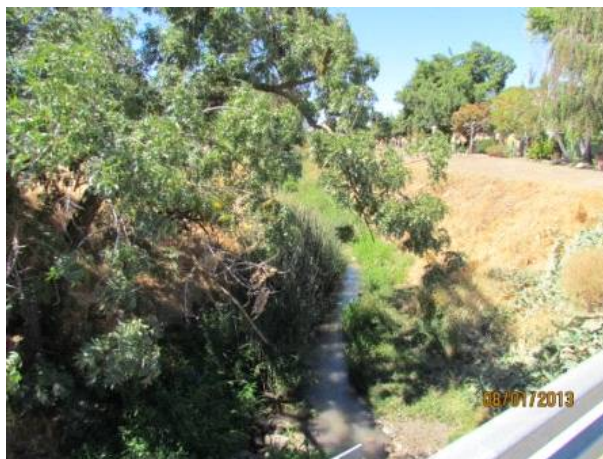
Levee Mile Report Line	6
Start Levee Mile	0.00
End Levee Mile	0.00
Location	
Category	Channels
Item	Vegetation & Obstructions
Downstream view Childs Ave. crossing.	
mkhashch_c_20130805_054.JPG

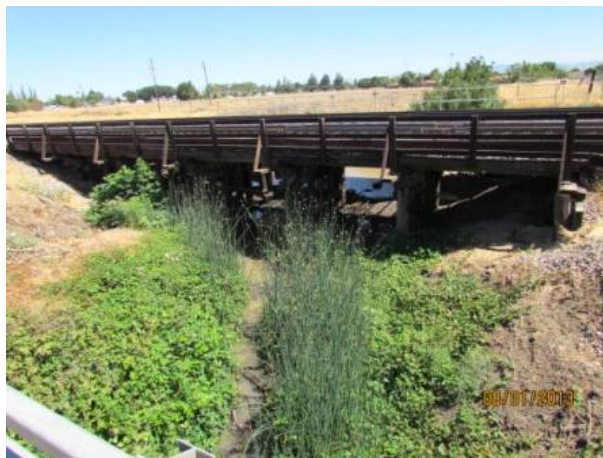
Levee Mile Report Line	11
Start Levee Mile	0.00
End Levee Mile	0.00
Location	
Category	Channels
Item	Vegetation & Obstructions
Santa Fe Dr. crossing looking upstream.	
mkhashch_c_20130805_055.JPG

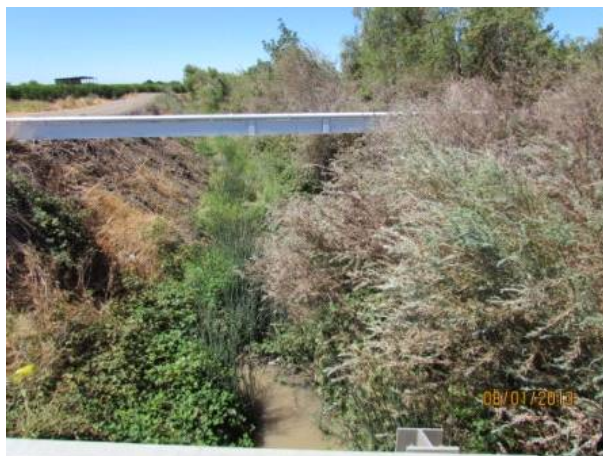
mkhashch\_c\_20130805\_056.JPG

Santa Fe Dr. crossing downstream view, note woody vegetation on right side of channel.

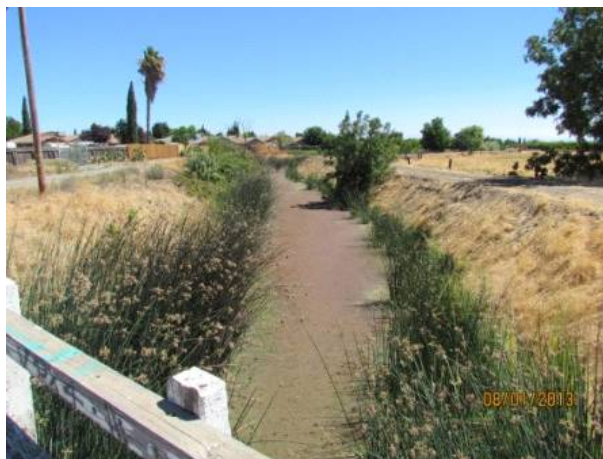
mkhashch\_c\_20130805\_057.JPG

Plainsburg Road upstream view.

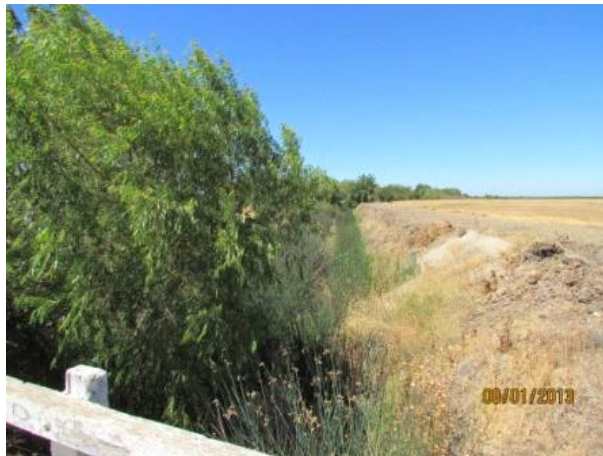
mkhashch\_c\_20130805\_058.JPG

Plainsburg Rd crossing, downstream view, Note woody vegetation on left side of channel.

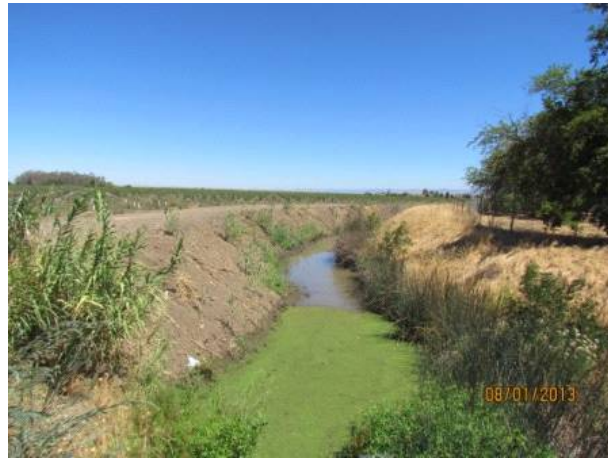
mkhashch\_c\_20130805\_059.JPG

Upstream view from Gerard Ave. crossing.

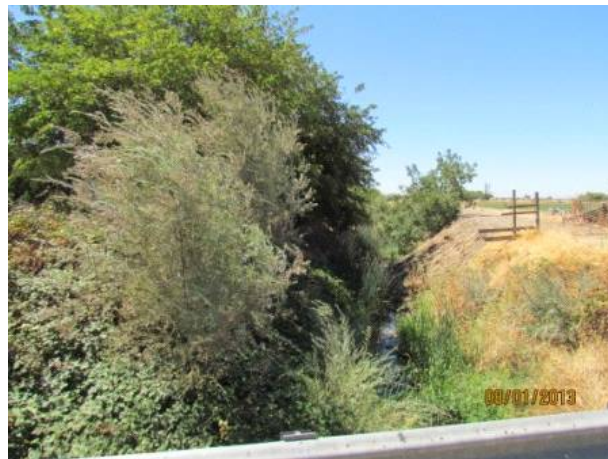
mkhashch\_c\_20130805\_060.JPG

Downstream view from Gerard Ave. crossing.

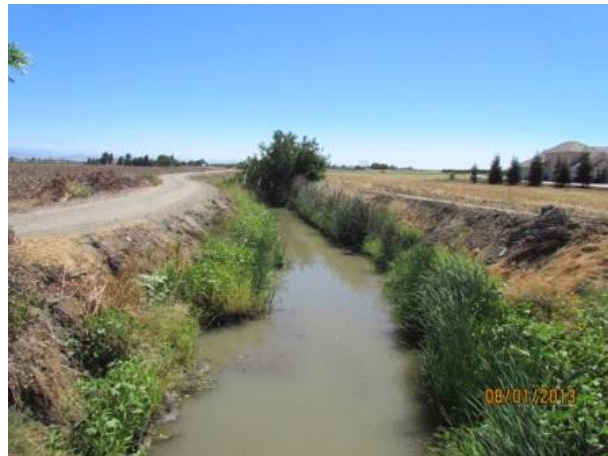
mkhashch\_c\_20130805\_061.JPG

Upstream view from Whealan Rd. crossing.
